MISSION STATUS BULLETIN

VOYAGER

March 1, 1978

No. 16

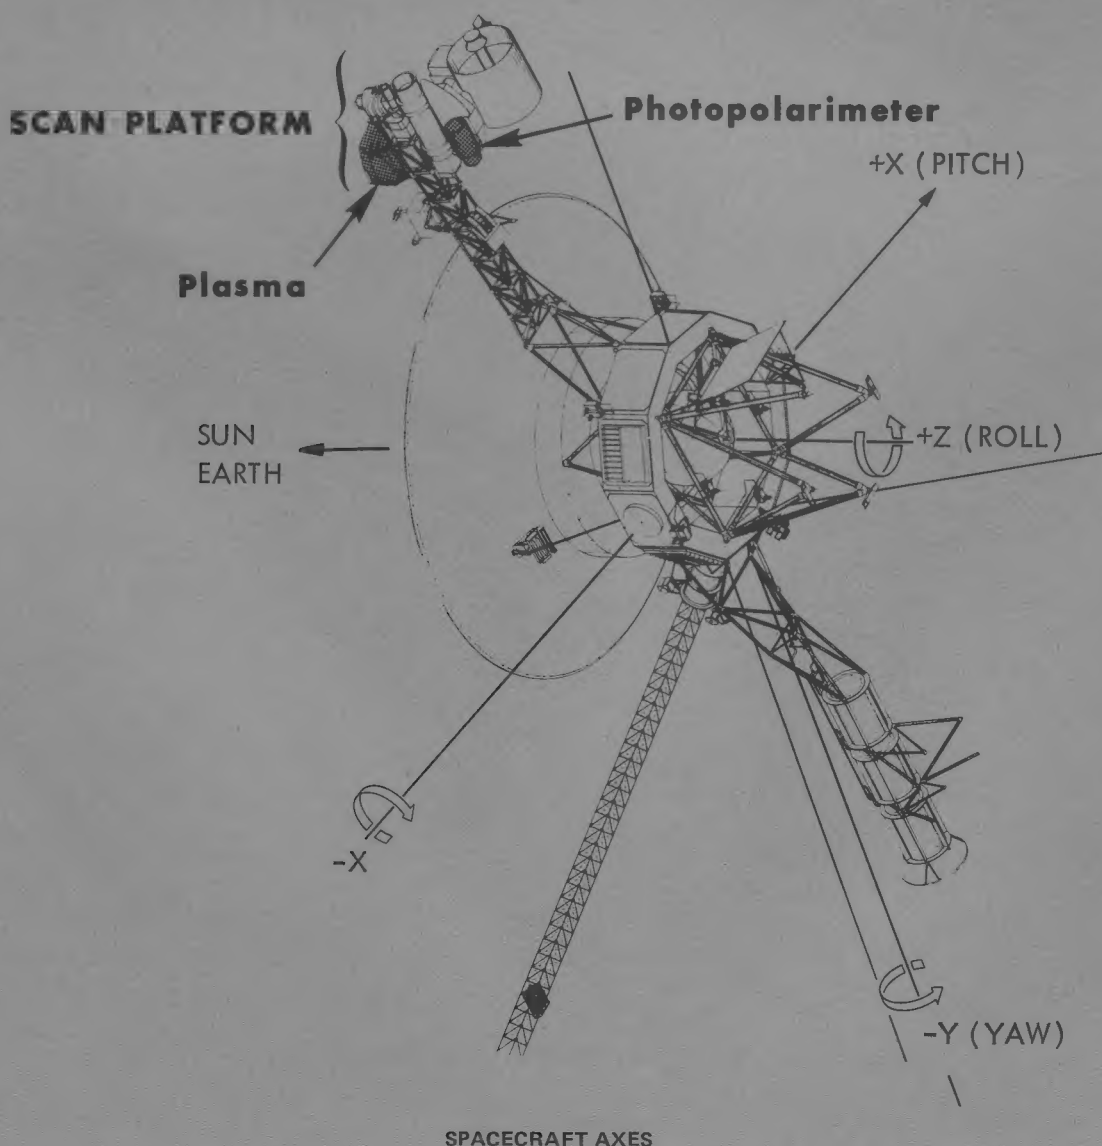
PHOTOPOLARIMETER (PPS). In the normal operating mode, the instrument steps through 40 filter/analyzer wheel combinations every 24 seconds.
